**PNRF BARKING SANDS
CABLE INSPECTION 1983**

**FPO-1-83 (39)
OCTOBER 1983**

**ROBERT TAGGART INCORPORATED
FAIRFAX, VIRGINIA**

**OCEAN ENGINEERING AND CONSTRUCTION PROJECT OFFICE
CHESAPEAKE DIVISION
NAVAL FACILITIES ENGINEERING COMMAND
WASHINGTON, D. C. 20374**

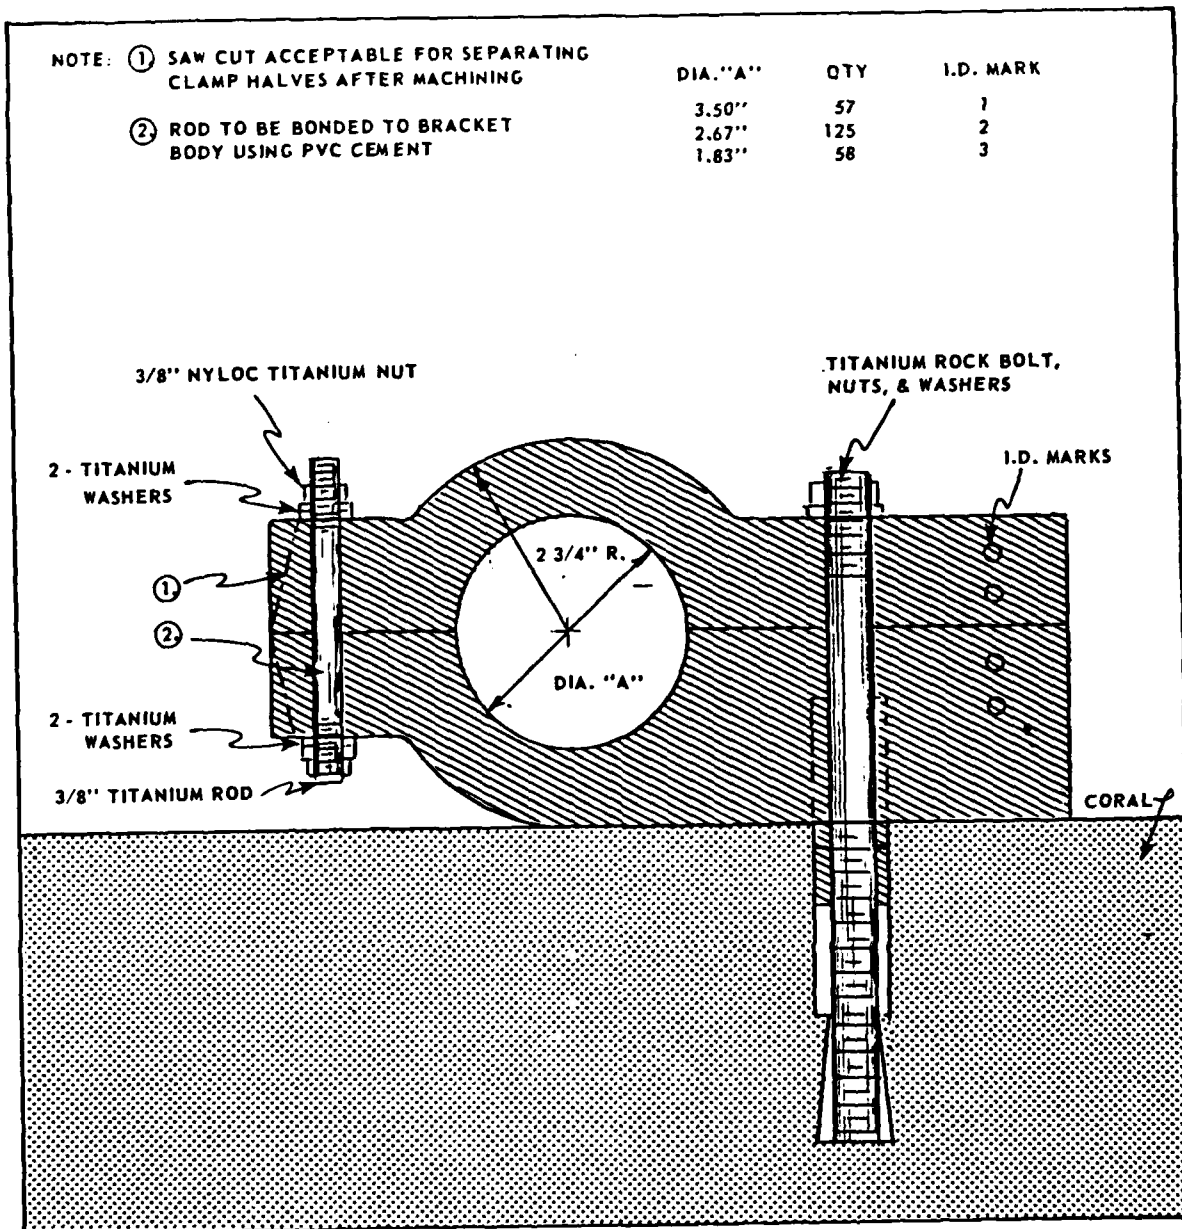
FIGURE 5-1

ONE-BOLT CABLE CLAMP ASSEMBLY DRAWING

During the 1977 BSURE construction activities, a number of single-bolt clamps were utilized for securing cables to the sea floor. A typical example is shown in Figure 5-1.

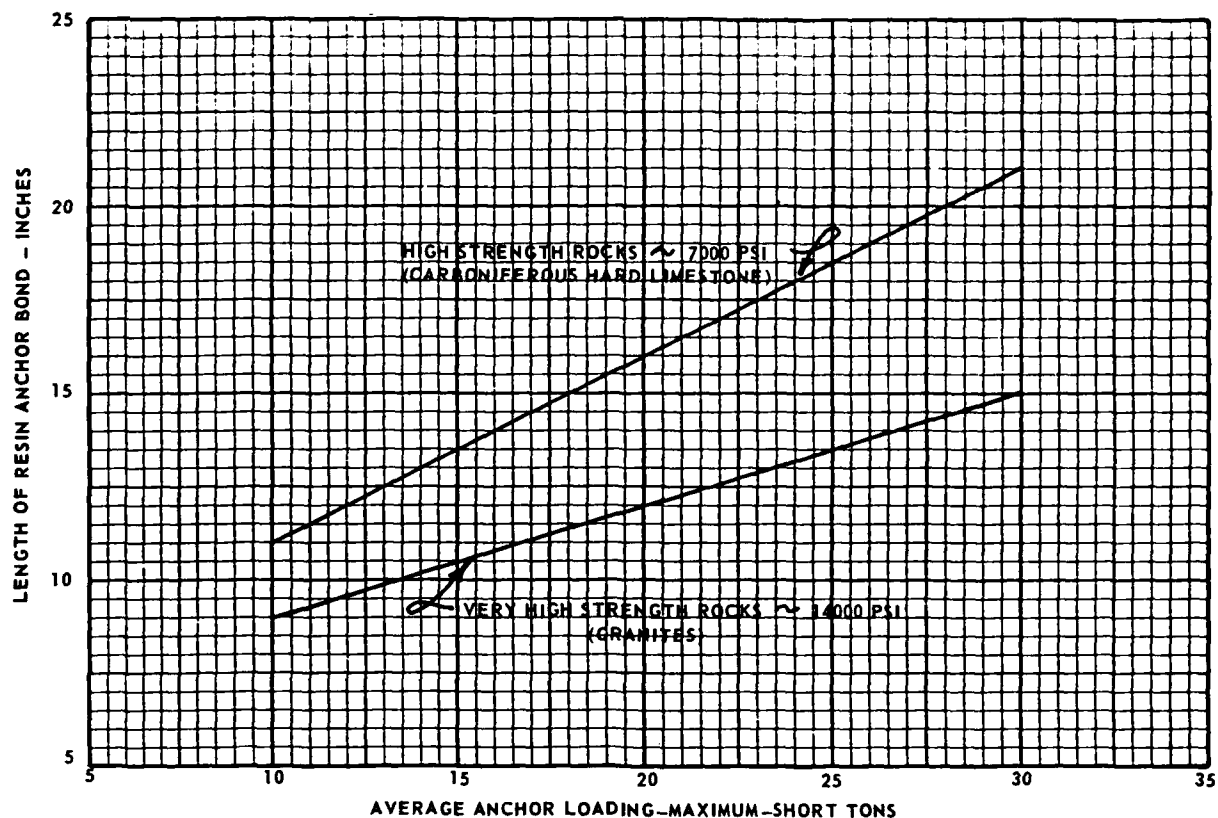
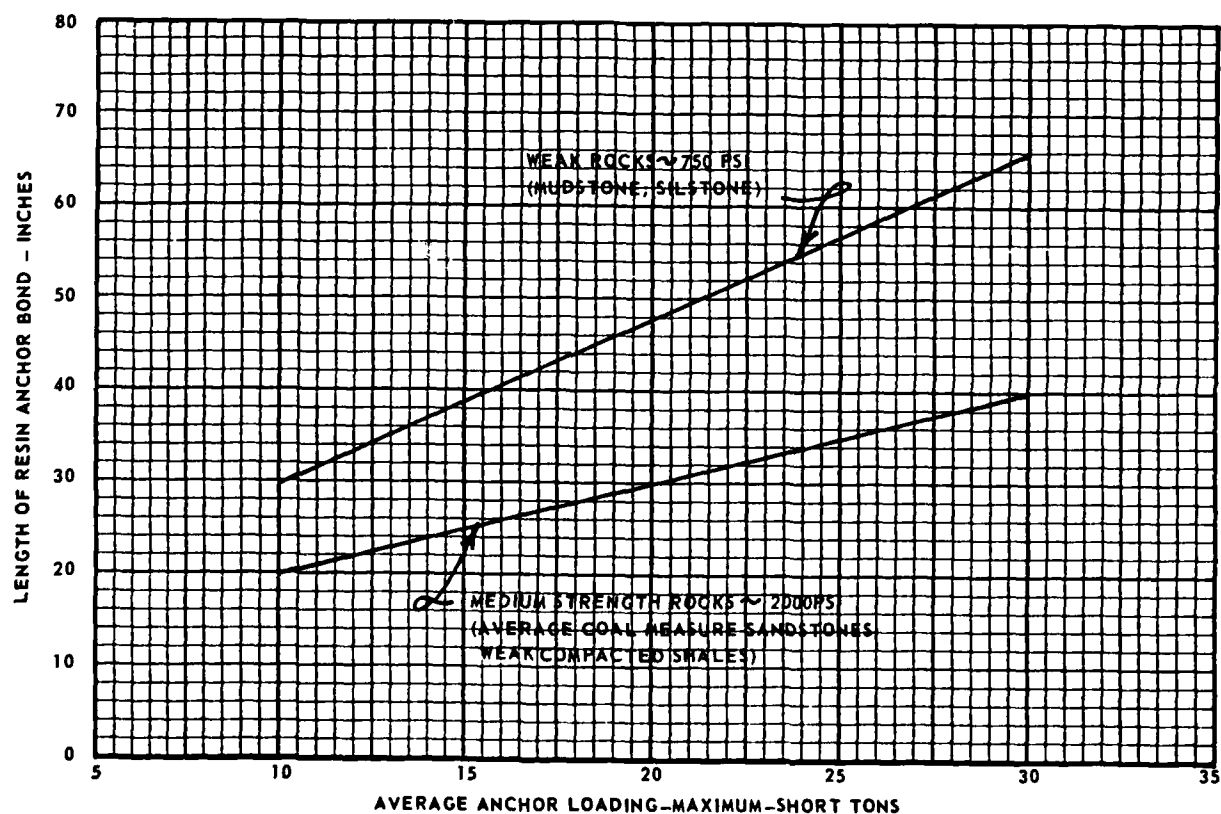
FIGURE C-1

The holding power of this epoxy cement is excellent in all types of rock structure as illustrated in Figure C-1. These anchorage loadings are based upon trials conducted by the Imperial College, London. The availability of this material will contribute significantly to future ocean construction projects.

TYPICAL ANCHORAGE LOADINGS FOR POINT ANCHORED CELTITE ROCKBOLTS
